## Primary PCI

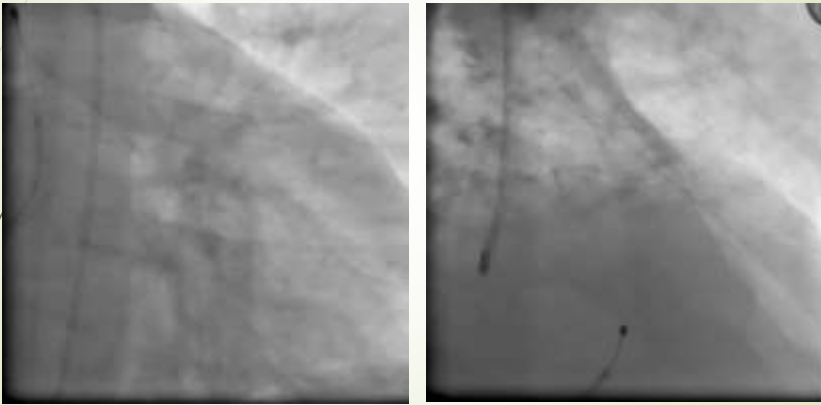
Temporary pacemaker wire  
Left coronary angiography

The top slide features a light green background with a red arrow pointing right on the left side. A text box contains the title "Temporary pacemaker wire" and "Left coronary angiography". Below the text are two side-by-side grayscale angiographic images. The left image shows a coronary artery with a thin, dark wire inserted. The right image shows a similar view from a slightly different angle, highlighting the wire's position within the vessel lumen.

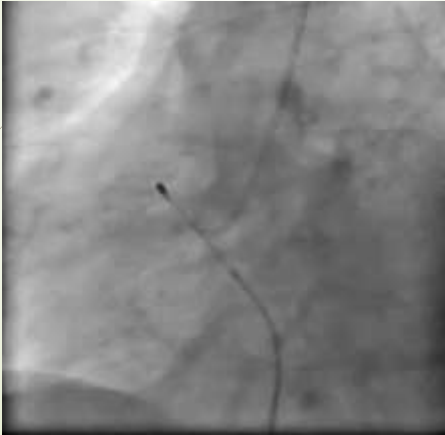
The bottom slide has the same light green background and red arrow as the top slide. It contains a single, larger grayscale angiographic image. This image shows the same coronary artery and wire as the top slide, but from a different perspective, providing a more detailed view of the wire's placement and the vessel's anatomy.

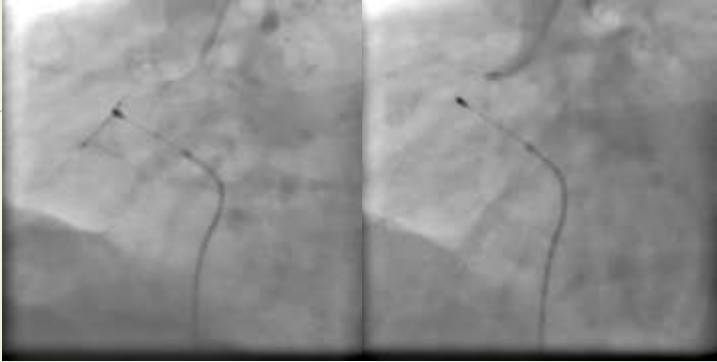
JR 6F  
BMW wire then PT2 LS  
Aspiration catheter failed to pass  
2.5 X 20 mm Balloon

The image consists of two side-by-side fluoroscopic views of a blood vessel. In the left view, a thin wire is visible, curving through the vessel. In the right view, a thicker catheter is visible, following a similar path but appearing to be blocked or unable to advance further.

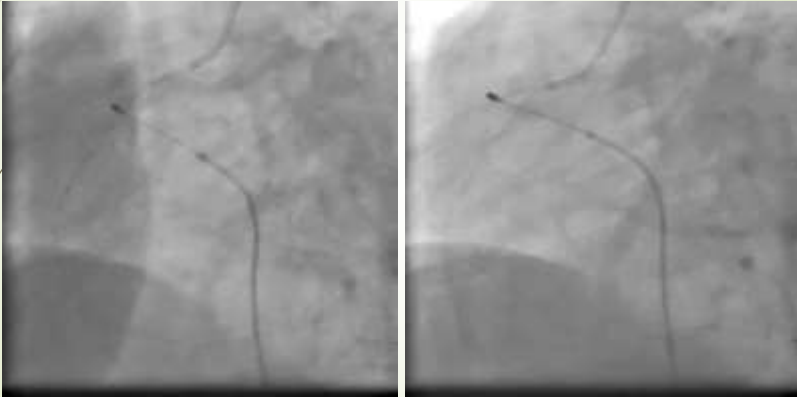
Passing Aspiration catheter

The image consists of two side-by-side fluoroscopic views of the same blood vessel. In the left view, the aspiration catheter is positioned at the site of the previous blockage. In the right view, the catheter has successfully advanced further down the vessel, demonstrating the successful passage.

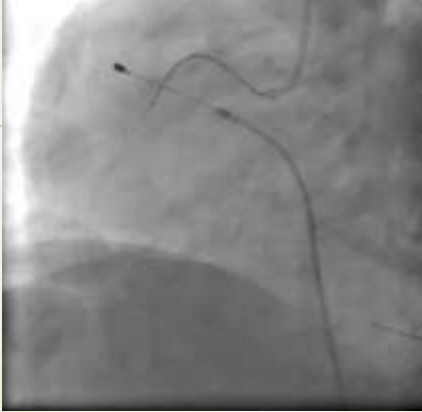
Failed passage of 3.0 X 38 mm EES

A fluoroscopic image showing a catheter with a guidewire inserted into a vessel. A red arrow points to the catheter tip, which is positioned in a vessel that appears to be partially occluded or narrowed, indicating a failed passage of the 3.0 X 38 mm EES.

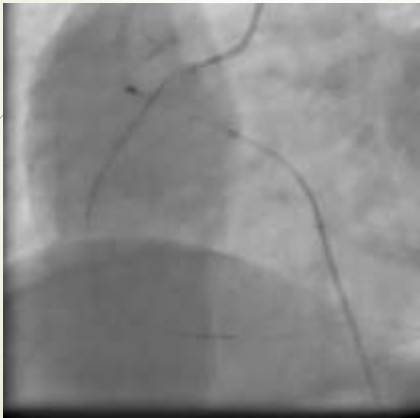
3.0 X 38 mm EES at 14 atm

This slide features a light green background with a dark grey vertical bar on the left side. A red arrow points to the right from the top of this bar. The text "3.0 X 38 mm EES at 14 atm" is positioned to the right of the arrow. Below the text is a square fluoroscopic image showing a catheter with a curved tip inside a vessel. The vessel lumen is visible as a darker area, and the catheter's shaft and tip are clearly defined against the lighter background of the vessel wall.

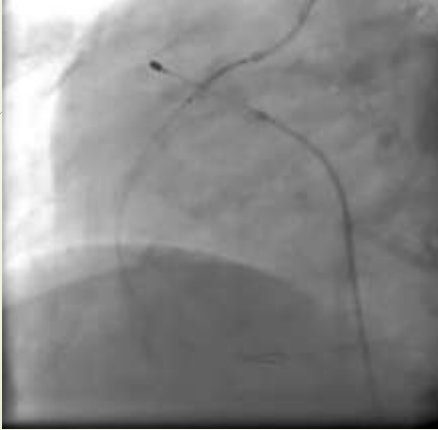
3.5 X 16 mm EES in proximal RCA (at 14 atm)  
Withdrawal of PT2 LS wire before inflation

A fluoroscopic image showing a coronary artery. A thin, dark wire is visible, extending from the top left towards the center of the frame. The background is a light, grainy texture, likely representing the surrounding tissue or the X-ray beam's path.

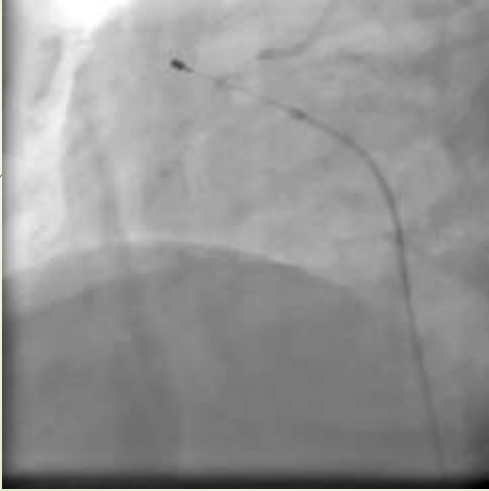
Final

A fluoroscopic image showing a coronary artery. The wire is no longer visible, indicating its withdrawal. The background is a light, grainy texture, similar to the previous image.
